### The Earth From Afar: Image Review

## Post Tsunami Reconstruction: The Semen Andalas Cement Plant in Aceh, Indonesia

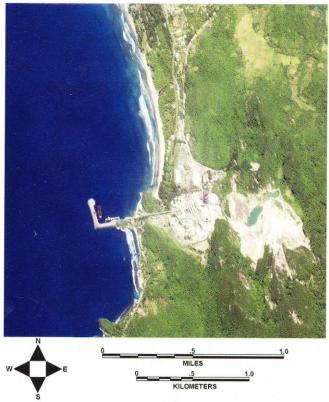
Figure 1 is a Space Imaging's IKONOS satellite image taken on January 10, 2003, almost one year before the tsunami. The image shows the Semen Andalas cement plant, its dock facilities, and the limestone quarry immediately behind the plant. Frequently in developing regions, a company provides employees housing near a plant. In this case the plant's housing complex of 35 buildings lies 0.5 km from the plant on the seashore. This complex was the home for 100 employees and family members (Portland Cement Association). Based on the beautiful beach area and the lush tropical vegetation shown in the image, people living in this complex had a comfortable life style.

Figure 1 This image was taken by Space Imaging's IKONOS satellite on Jan. 10, 2003. Image acquired and processed by the Centre for Remote Sensing, Sensing and Processing (CRISP), National University of Singapore, IKONOS Image © CRISP 2004.

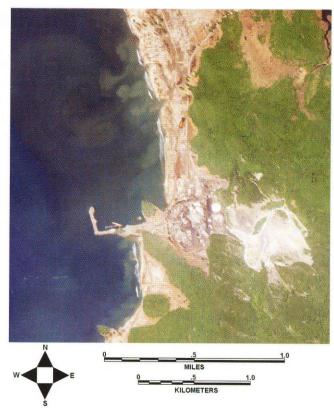
Figure 2 This image was taken by Space Imaging's IKONOS satellite on Dec. 29, 2004. Image acquired and processed by the Centre for Remote Sensing, Sensing and Processing (CRISP), National University of Singapore, IKONOS Image © CRISP 2004.

Figure 2 was also taken by Space Imaging's IKONOS satellite but on December 29, 2004, three days after the tsunami. The light brown color shown in this image represents the area decimated by the tsunami. With the exception of a few trees all vegetation was removed and only bare soil remains. Not one of the 35 houses survived. Figure 3 provides a ground view looking down toward the cement plant. The beach is gone and the area that was directly behind it is completely devastated. The tsunami waves that cut across this area were around 15 m (49 ft) to 25 m (82 ft) in height. The only evidence of human existence here are some building platforms, two non-functional roads, and a large barge with an accompanying tugboat. Figure 4 shows the barge and tugboat, which were washed ashore by the tsunami. They also can be detected in Figure 2. The barge still contains 400 tons of coal that was being delivered to the cement plant. As the waves came across the beach zone, they ran up the lower slopes of the hillsides. The maximum run-up of 34.5 m (113 ft) occurred on the hillside behind the barge (Figure 2), illustrating the power of the waves that forced the barge on the beach.

Figure 2 also shows a feature situated at a slight angle to the dock. This feature is a 6,693 dwt cement carrier "Sinar Andalas" that was capsized (Figure 5). Of the 19 crew members, only four survived. This ship contained cement that has now become concrete at the capsized site, making it a major barrier in clearing and rebuilding the dock. It was

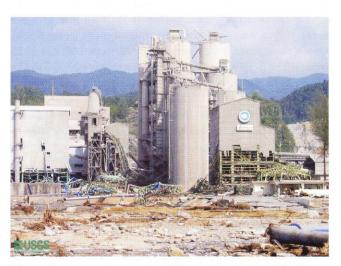
used to transport cement to Belawan, Lhokseumawe and Batam Island for packing. The cement plant also encountered significant damage (Figure 6). Of the 625 people working at the plant, 262 are still missing. Initial estimates indicate that it will take nearly 100 million US dollars to put the plant and dock back into operation (Risk Management Solutions). A comparison of Figures 1 and 2 shows how the coastline has been eroded back to the perimeter of the plant.

Figure 6 Damaged cement plant. Picture taken by the United States Geological Survey.

Before the tsunami occurred, the Semen Andalas plant was experiencing low profits and Lafarge had to evaluate the potential post tsunami market before committing to rebuild. On July 7, 2005, Lafarge announced that it would rebuild the damaged cement plant at a cost of US \$90 million. Risk Management Solutions, Inc. (RMS) (2005) reported that the Semen Andalas plant and the complex of 35 homes should receive about US \$100 million in natural disaster insurance; thus, most of the cost to rebuild should come from insurance compensation and not directly from Lafarge. The facility was heavily reinsured in both the Paris and London markets (Aloviai, 2005). The new plant will have state-of-the-art technology, which will make it more automated, and thereby, decrease labor and energy costs. The plant will resume operations in mid-2007 and will produce 1.6 million tons of cement annually.
