Haitian Earthquake, January 12, 2010

Haiti Earthquake 2010

Location: Port-au-Prince, Haiti
Images Dates: Before: April 25, 2009 After: January 24, 2010
Images Sources: QuickBird, Natural Color
Inset Image: Location of Haiti and Port-au-Prince between the Enriquillo-Plaintain Garden Fault (EPGF), the Septentrional-Oriente Fault (SOF)

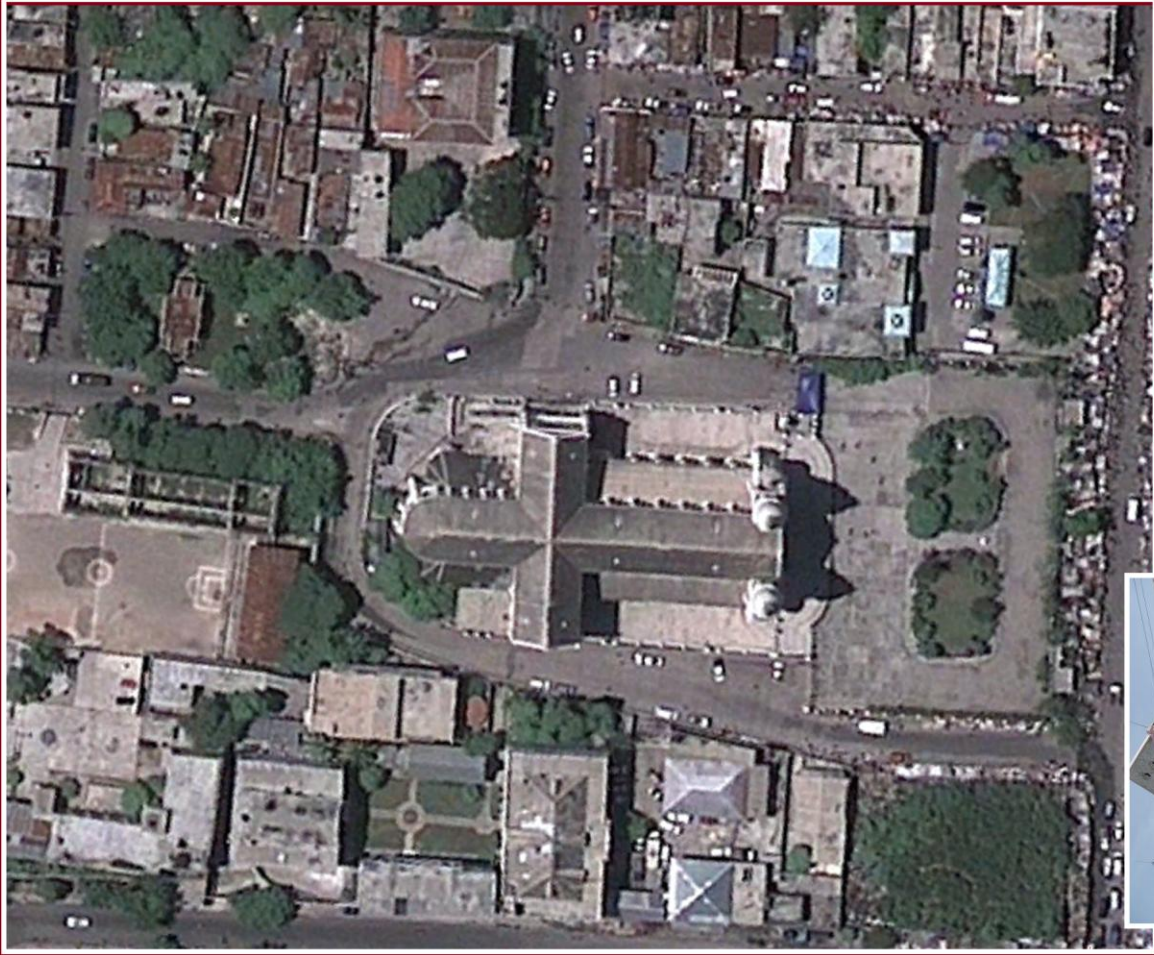
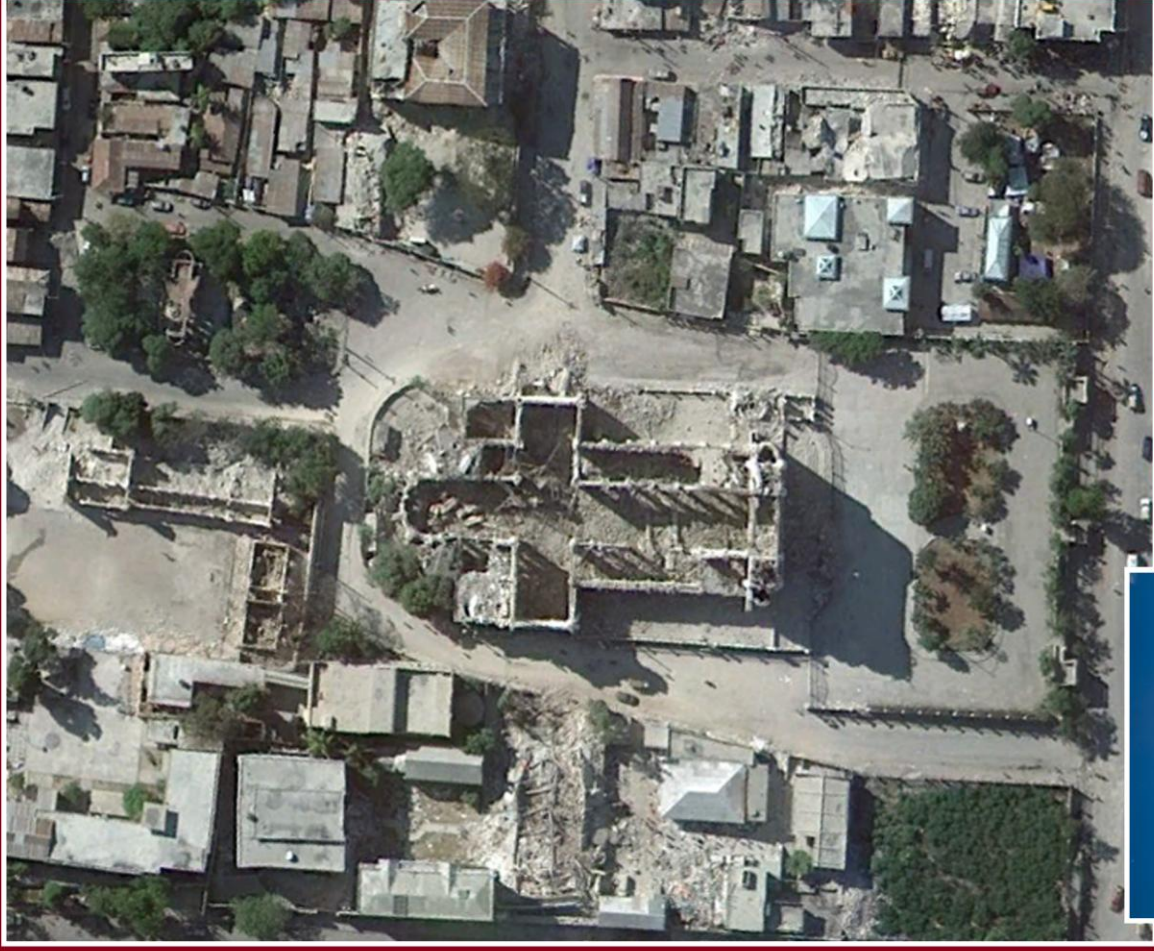
April 25, 2009

January 24, 2010

The two images cover an historical section of Port-au-Prince. They were acquired by DigitalGlobe's QuickBird satellite. The first image was taken before the earthquake on April 25, 2009, and the second image on January 24, 2010, twelve days after the earthquake. Haiti is 80 percent Catholic and the Cathedral, often viewed as one of the "sturdiest buildings" within the city, served as a hurricane shelter and aid distribution center. The large building laid out in the shape of a cross is the Roman Catholic Cathedral of Our Lady of the Assumption. The Cathedral, almost one hundred years old, was severely damaged. Archbishop Joseph S. Miot was killed when the roof collapsed. A comparative examination of the two images provides a visual example of the degree of damage throughout the city. An examination of the images shows that the Cathedral's roof dropped straight down into the building. Very little debris occurs outside the building. The walls may not be structurally sound. The roofs on several surrounding buildings also collapsed inward. However, the roofs on most of the buildings appear to have received little damage.

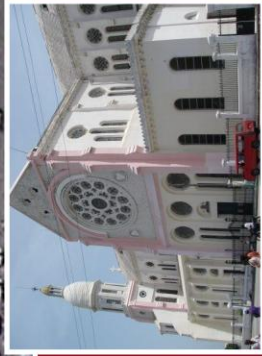
Ground Picture: Side Entrance of Church
Before the Earthquake

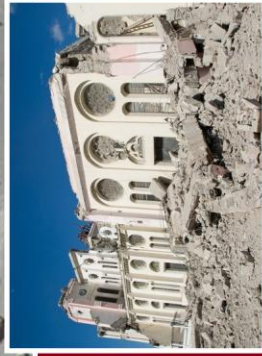
Ground Picture: Side Entrance of Church
After the Earthquake
