GEOCARTO

A Multi-disciplinary Journal of Remote Sensing & GIS

Powhatan, Louisiana: A Case Study in River Morphology

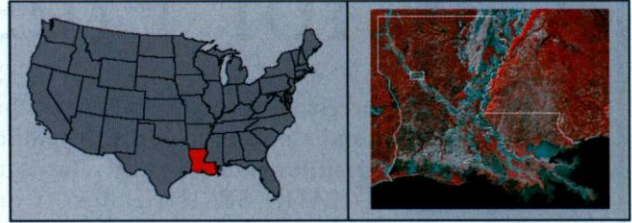
This high-altitude, color infrared aerial photograph shows a section of the Red River Valley of Louisiana. It was taken on December 5, 1983 and covers an area of approximately 12.8 kilometers (8 mi) by 8 kilometers (5 mi). The hamlet size community of Powhatan (1990 Population, 147) is situated in the south central section of the image and a portion of the village of Campti (1990 Population, 929) is located on the image's eastern edge. The nearest large communities are Natchitoches, about 16 kilometers (10 mi) to the southeast, and Shreveport, 105 kilometers (65 mi) to the northwest. The corresponding topographic map comes from the 15-Minute U.S. Geological Survey Quadrangle for Campti, Louisiana which was published in 1957.

From the image area, the Red River enters into the Mississippi River, nearly 161 kilometers (100 mi) downstream, and represents the Mississippi's last major tributary before it flows into the Gulf of Mexico. Large rivers are often divided into three sections - their upper, middle, and lower courses. The image shows the Red River as being at its lower course level. At this level a river often changes its path as it slowly moves across a very flat floodplain. Within the twenty-six year period separating the map and the image, the river changed its course. Compare the location of the river on both the image and the map. In addition, the large distances between the contour lines on the map indicate a relatively flat condition, typical of a floodplain. This is also demonstrated by the agricultural fields on the image where farmers are taking advantage of the rich alluvial soil and flat land for growing crops. The poor drainage pattern shown on both the image and map further implies a low slope condition.

river are oxbow lakes and scars, cut banks and point bars, and channel and slough fillings. They provide evidence of a river shifting over time. Oxbows generally form during flood periods when a section of the meandering river channel is cut off as the river attempts to shorten and straighten its path. (The term "oxbow" is derived from the U-shaped collar placed around an ox's neck to support the yoke.) The Old River is a classical oxbow lake. Note how the lake's water color is darker than the river which indicates stagnant versus flowing water. These lakes frequently dry up leaving scars on the landscape. Lake Paule d'eau is gradually converting from being an oxbow lake to an oxbow scar. The image shows a portion of the former lake, in white, which is now solid land and has been incorporated into an agricultural field. The image also exhibits the water section, according to the map, of the oxbow as being red in color. Since the image is in color infrared, items displayed in red indicate vegetation. The brighter the red the healthier the vegetation. It appears that the lake is covered with vegetation and in its final stage as a water body.

A river erodes the outside bank, known as the cut bank, of a meander loop and deposits materials on the inside of the loop forming a point bar. Centrifugal force whips the water out as it goes around the loop removing sediment from the outside bank. The one cut bank near Old River is moving the river closer to the community based on its location on the map in relationship to the image. The water on the inside of the loop flows at a slower rate and does not have the velocity to carry much sediment. These conditions can be observed on both the image and map. On the image the sediment deposits near the river appear white due to the high reflectance from their non-vegetated, sandy surfaces. On the map these areas are depicted by stippled brown patterns. Compare the areas on the map to those on the image to determine where new sediment is occurring as the river changes its channel.

As the water whips around the outside bank of the meander loop, it also circulates in a spiral pattern as it flows downstream, which creates a deeper channel on the outside bank. Note the difference in the water color as it moves around a loop.

Channel and slough fillings are the result of chute-type cutoffs which differ from the neck-type cutoffs related to the development of oxbows. A chute-type cutoff occurs when a river cuts across a point bar and creates a new channel. The flow of water through the old channel is slowly reduced, and eventually, the channel is abandoned creating a bar-and-swale relief. The channel is initially filled with silty-sand materials and finally with clay. Directly north of Powhatan on the south side of the river is an example of channel and slough fillings. A comparison of the river's location on both the image and map shows that the river has shifted northward cutting across a point bar. The dark colored vegetation and elongated water bodies indicate relatively recent filling with most likely silt and sand. The area immediately to the west is older and has more clay in the soil. A number of examples of channel and slough fillings can be found on the image.

Due to flooding, a river's path can change. In addition to identifying long-lot parcels, the red lines on the map outline the location of the river when the system was initially

surveyed. The lines circle around Old River but they then cross the present river and form a different path. In following this path across the map it is possible to trace the entire length of the river channel. Between the image and the map three different channels of the Red River can be determined.

Although laid out as part of the long-lot survey system, this area, in general, never developed in this manner. Only the section around Old River truly reflects the long-lot settlement pattern. The image shows long, narrow fields spreading out from the oxbow. The small black squares on the map indicate buildings, generally dwelling units. These squares line the banks of Old River relating to where a farmer's home and out-buildings were to be located under the long-lot system. They are not found along the present river, but instead, along roads and in the communities of Powhatan and Campti. A road has been built around Old River and is located between the river and the dwelling units. It links this area to Powhatan and provides a small levee. It also indicates that the river is not being used as a transportation route.

Finally on the north side of the river a mining operation can be detected on the image. The large pond is a detention reservoir to keep sediment from the operation from being

washed into the river. The white-colored, fan-shaped features are tailings which are depositing materials into predefined sections of the pond. These sections are eventually filled and form new land. Sand and gravel mining is very common on floodplains.
